Region VII - Falls Task Force

A Training Guide for Avoiding Fall Hazards in the Construction Industry

United States Department of Labor Occupational Safety & Health Administration

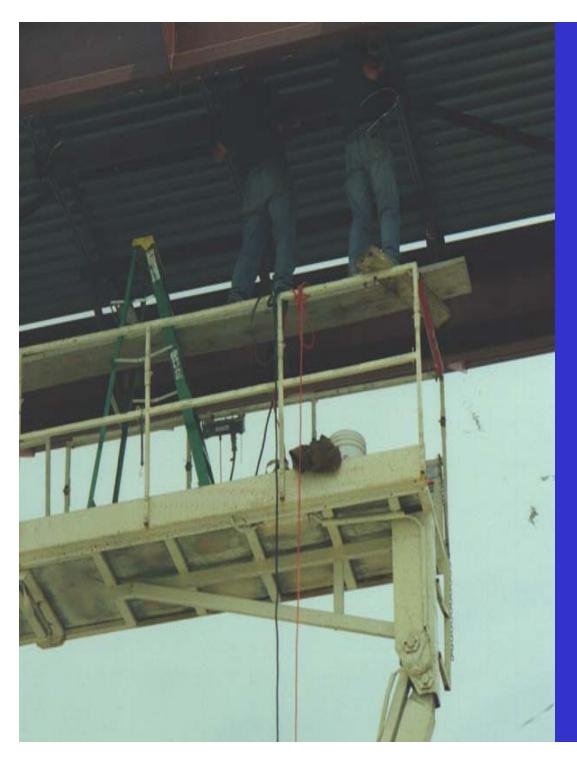
This is definitely <u>NOT</u> the appropriate way to use an aerial lift or a stepladder.

When using a lift, such as a scissors lift, the employee need not use any type of restraint. However, the employee must remain on the platform of the lift and the cage must have a guardrail system with endrails.

When using a lift that has an articulating boom, employees must wear a body belt and lanyard attached to the boom or basket as a restraint device

For further information on aerial lifts, refer to CFR 1926.453

For further information on ladders, refer to CFR 1926.1053 - .1060

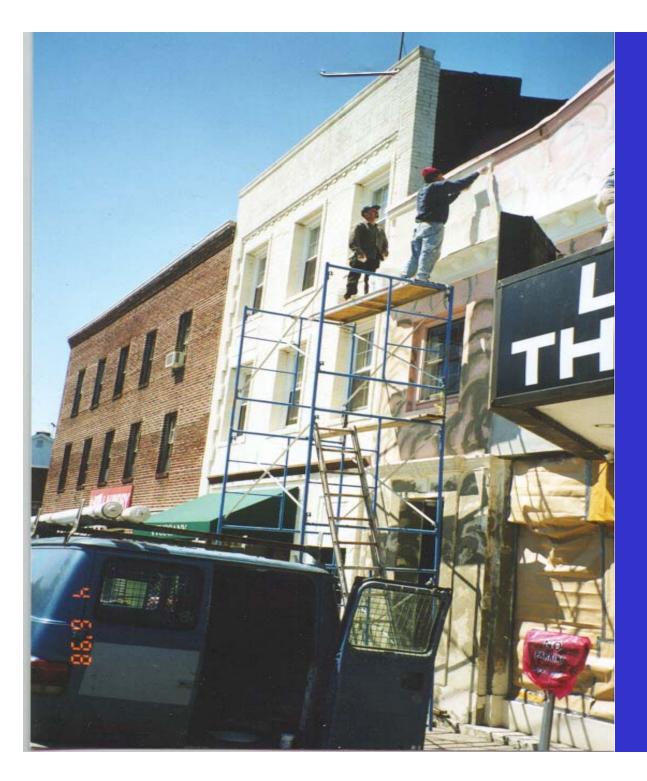
Can you explain the proper way this scaffold should have been set up?

- 1. Supported scaffold poles, legs, posts, frames and uprights shall bear on base plates and mud sills. 1926.451(c)(2)
- 2. Each platform on all working levels shall be fully planked or decked. 1926.451(b)(1)
- 3. Each employee on a scaffold more than 10 feet above a lower level shall be protected from falling. 1926.451(g)(1)
- 4. A suitable means of access shall be provided when scaffold platforms are more than 2 feet above or below a point of access.

1926.451(e)(1)

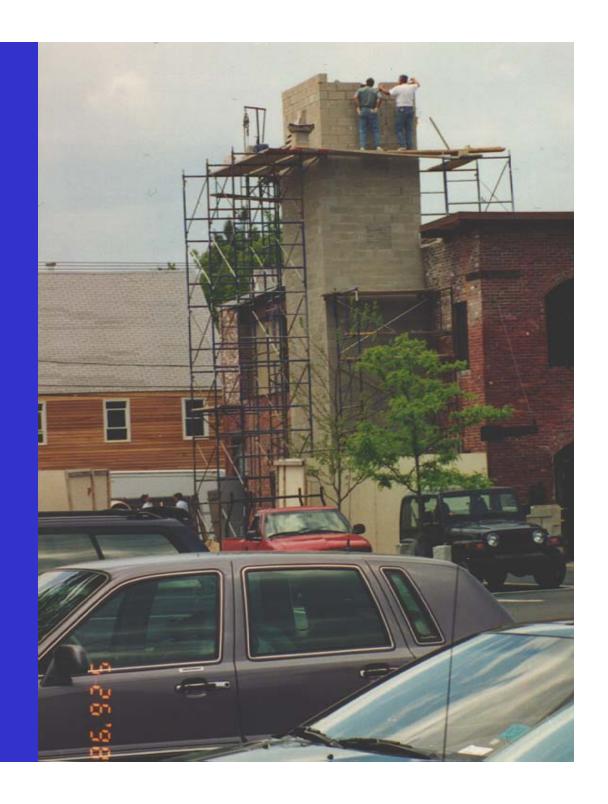
There can be no logical explanation why someone would risk their life while working on this scaffold.

What are some questions you would ask before working on this setup?

- 1. Is the wood capable of supporting, without failure, its own weight and at least 4 times the maximum intended load. 1926.451(a)(1)
- 2. Who is the qualified person that désigned this scaffold ? 1926.451(a)(16)
- 3. Who performed the daily inspection of the scaffold? 1926.451(f)(3)
- 4. What are some methods of fall protection these guys could have used? (Under 1926.451(g)(1) fall protection is to be used when an employee on a scaffold is more than 10 feet above a lower level.)

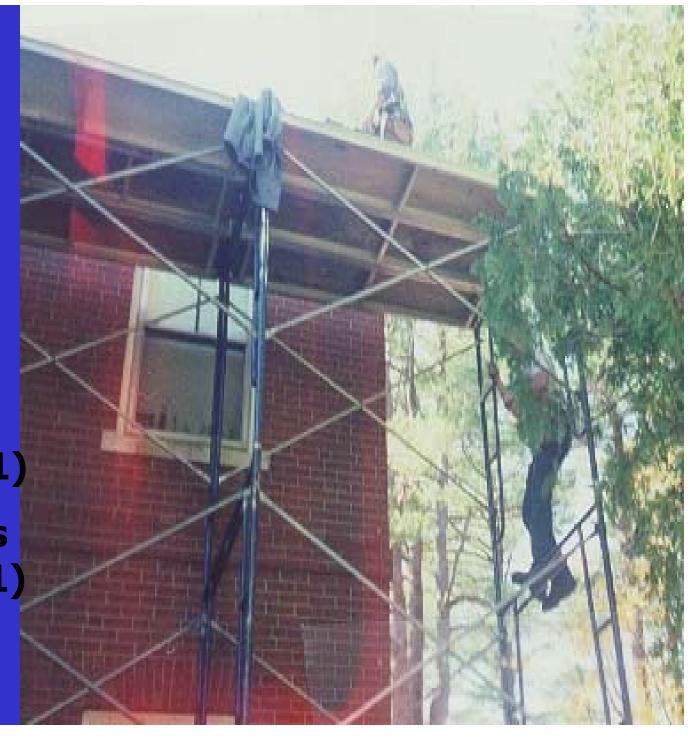
Two common scaffold violations:

No fall protection system. 1926.451(g)(1)

No safe access 1926.451(e)(1)

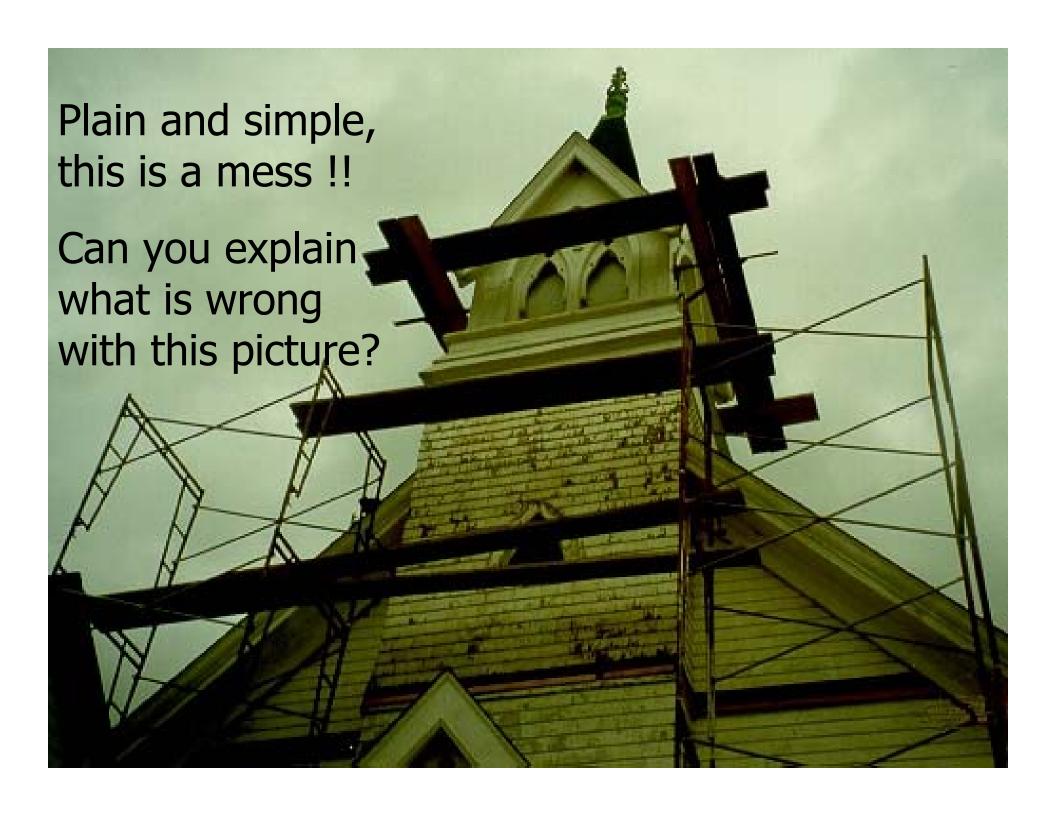
- 1. No support for the work platforms.
- 2. What is the means of access to the working levels?
- 3. What are the workers going to use for fall protection?
- 4. Is the scaffold adequately braced?
- 5. Was the scaffold erected under direction of a competent person?
- 6. Will the work platforms support at least 4 times their maximum intended load?
- 7. Will the work platforms support employees without tipping?
- 8. Is the scaffold tied off to the building at the proper height and width?

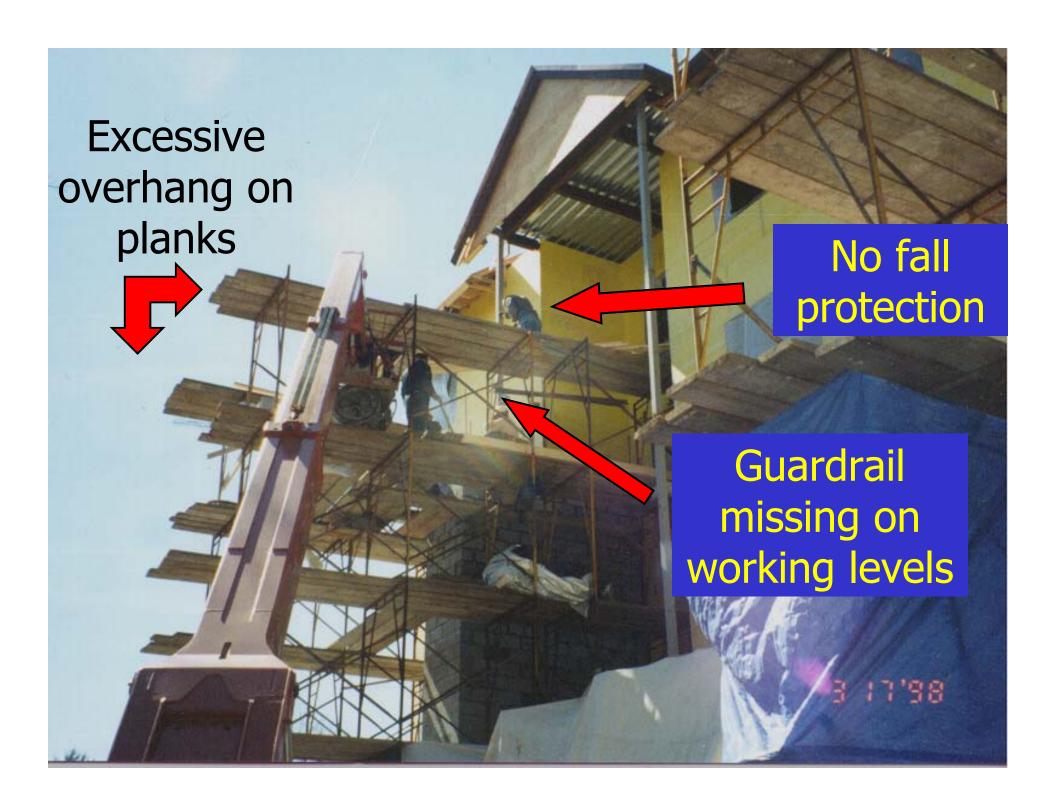
Before you start, develop a work plan so that situations like this can be avoided.

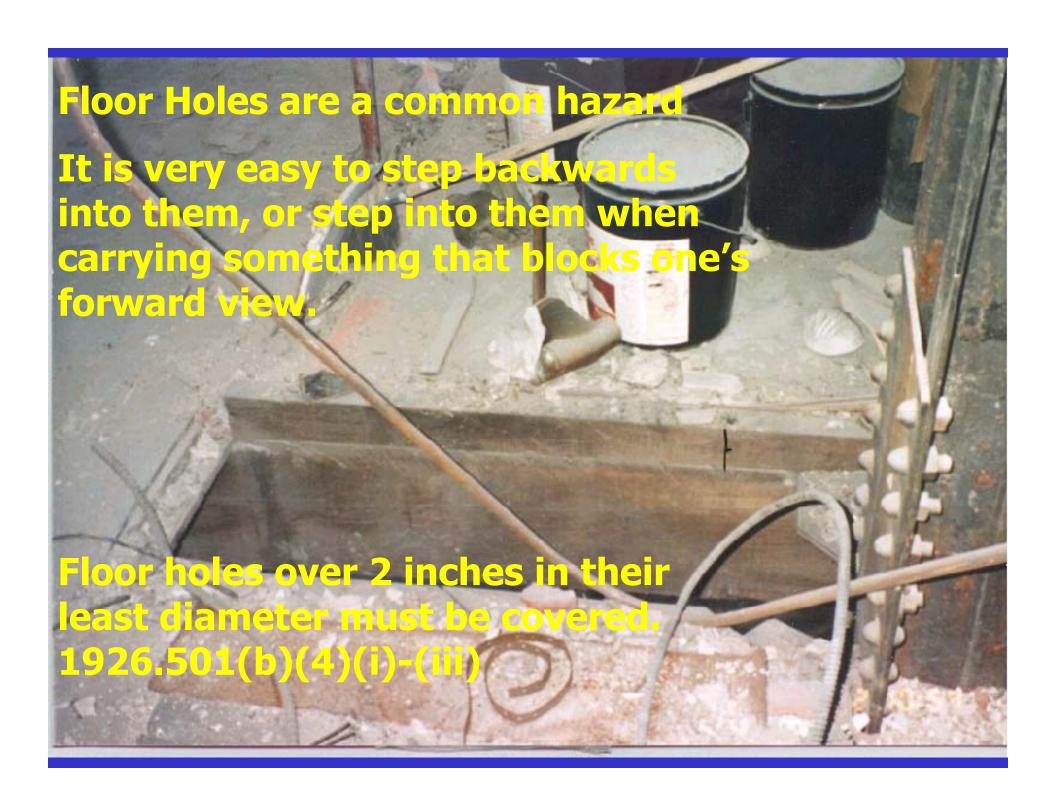
Floor covers must be marked and secured so that they are not removed and the hole left unguarded.

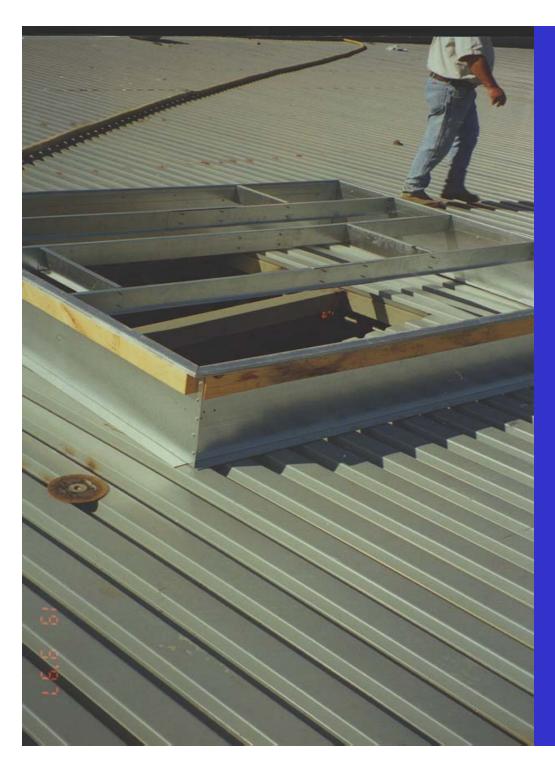
Roof openings (including skylights) must be be properly covered or employee fall protection provided in accordance with 1926.501 or 1926.760.

Covers must be marked "HOLE" or "COVER" and capable of supporting, without failure, 2X the weight of employees, equipment, and materials that may be imposed on the cover.

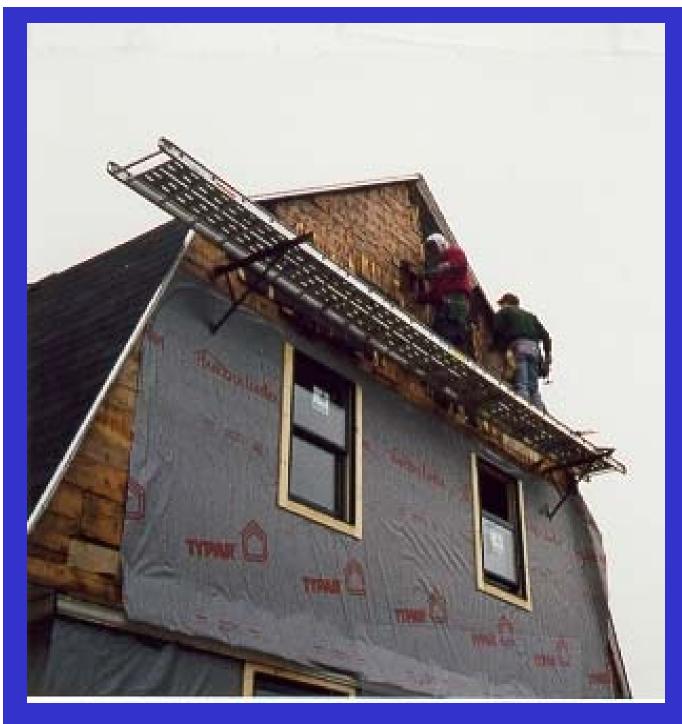
Again, there is no protective system installed. The workers could have used a harness or guardrail system along with end rails.

1926.451(g)(1)

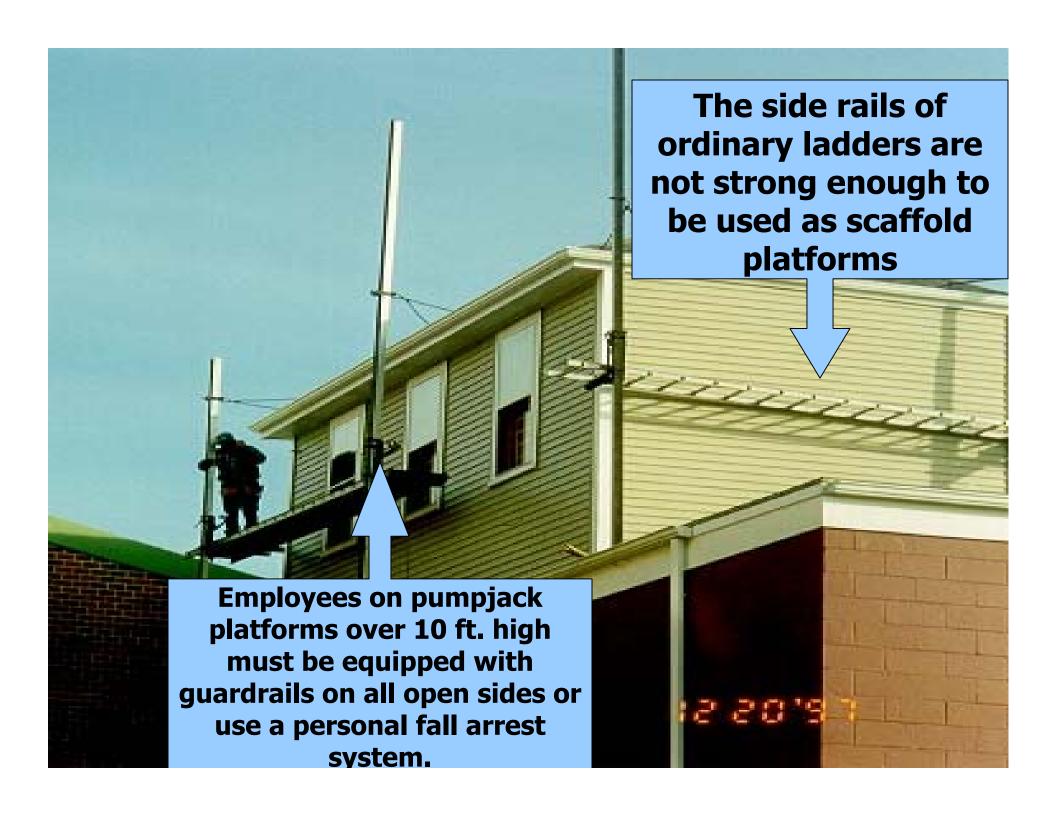
No fall protection system

Use appropriate size stepladder for the job

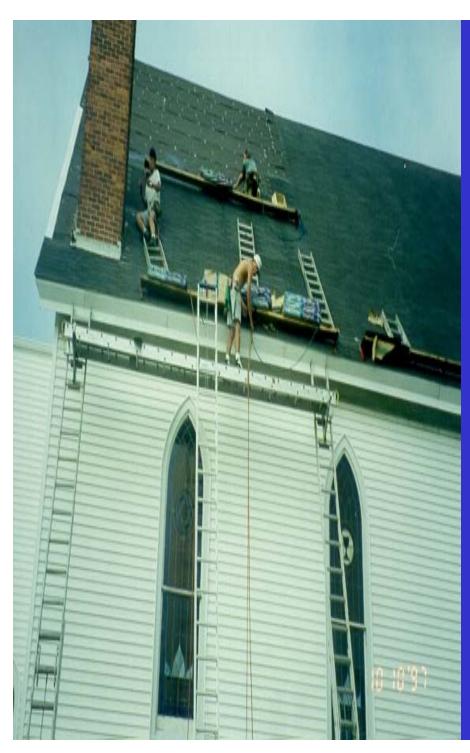
In a situation like this, full body harnesses with lanyards and/or a catch platform would be a suitable means of fall protection.

Additionally, guardrails should be installed on the ladder-jack scaffold or have the employee use a full body harness.

Reference 29 CFR 1926.501(b)(11) roof 1926.451(g)(1) scaffold

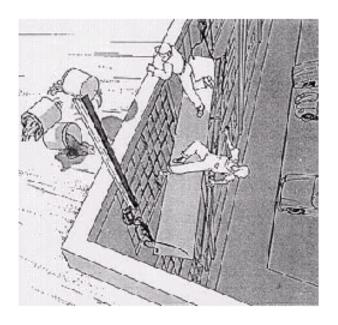
Two employees were painting the exterior of a three-story building when one of the two outriggers on their two-point suspension scaffold failed. One painter safely climbed back onto the roof while the other fell approximately 35 feet to his death. The outriggers were inadequately counterweighted with three 5-gailon buckets containing sand and were not secured to a structurally sound portion of the building. Neither painter was wearing an approved safety belt and lanyard attached to an independent lifeline.

As a result of its investigation, OSHA issued citations for five serious and two other than serious violations of its construction standards. OSHA's construction safety standards include several requirements which, if they had been followed here, might have prevented this fatality.
