HAZARD ALERT

Industry: Fish processing plant

Forklift tips over, crushing operator

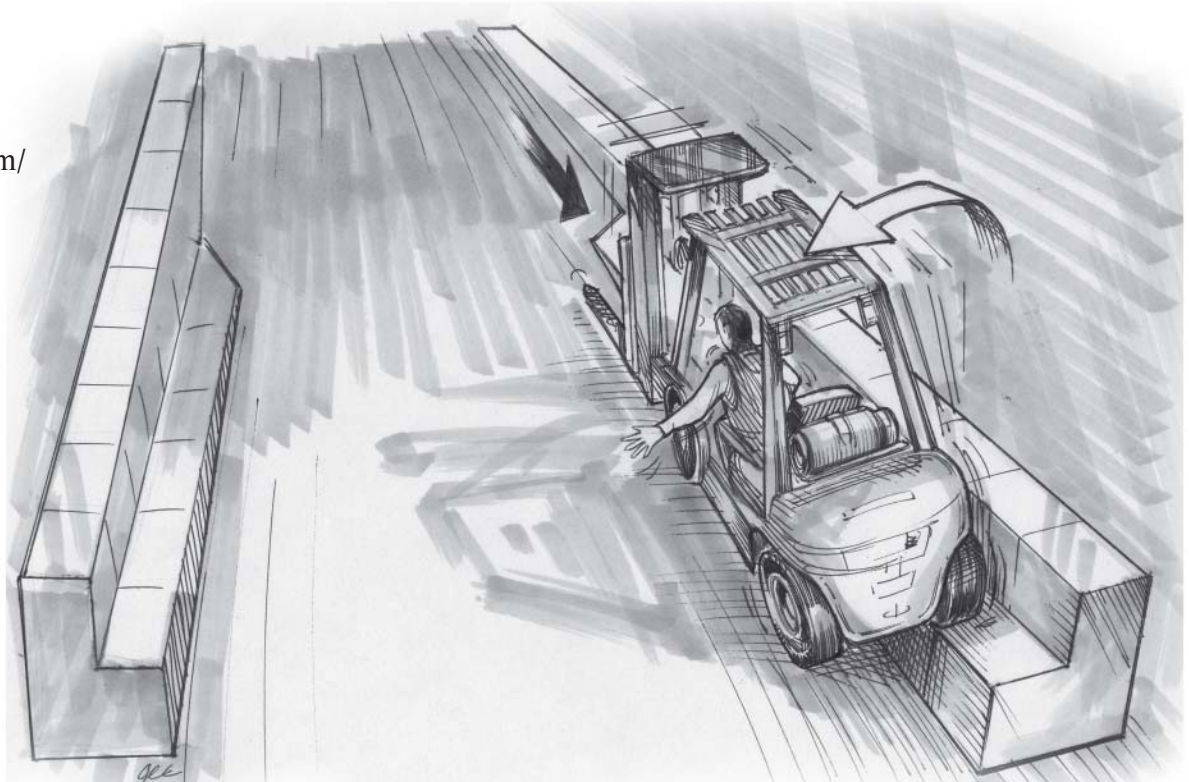
A forklift operator was loading empty totes onto a trailer at night. The loading dock ramp was poorly lit, and the forklift did not have rear lights that could give adequate lighting for travelling in reverse.

The operator was backing the forklift down the ramp. Its right wheels went onto a ledge on one side of the ramp, and a difference in elevation developed rapidly between the right and left sides of the forklift. The difference increased as the forklift moved backward. The forklift tipped over and the operator, who was not wearing a seatbelt, was partially ejected from the seat. The operator was trapped between the forklift and the ground, receiving fatal injuries.

- Eliminate forklift tipover hazards wherever practicable. Where tipover hazards cannot be eliminated, implement other methods of ensuring forklifts will not contact the hazards.
- Install the required general lighting in all work areas.
- Ensure forklifts have the required lights.
- Train operators to follow the manufacturer's instructions on how to prevent tipovers, and ensure they know how to react in the event of a tipover.
- Ensure seatbelts and other operator-protection devices are used if the forklifts were manufactured with them.
- Consider retrofitting older forklifts with seatbelts or other operator-protection devices. These are designed to reduce the risk of the operator's head and torso being trapped and crushed between the truck and the ground in the event of a tipover.
