FATAL

Forklift operators

Move cautiously when vision obstructed

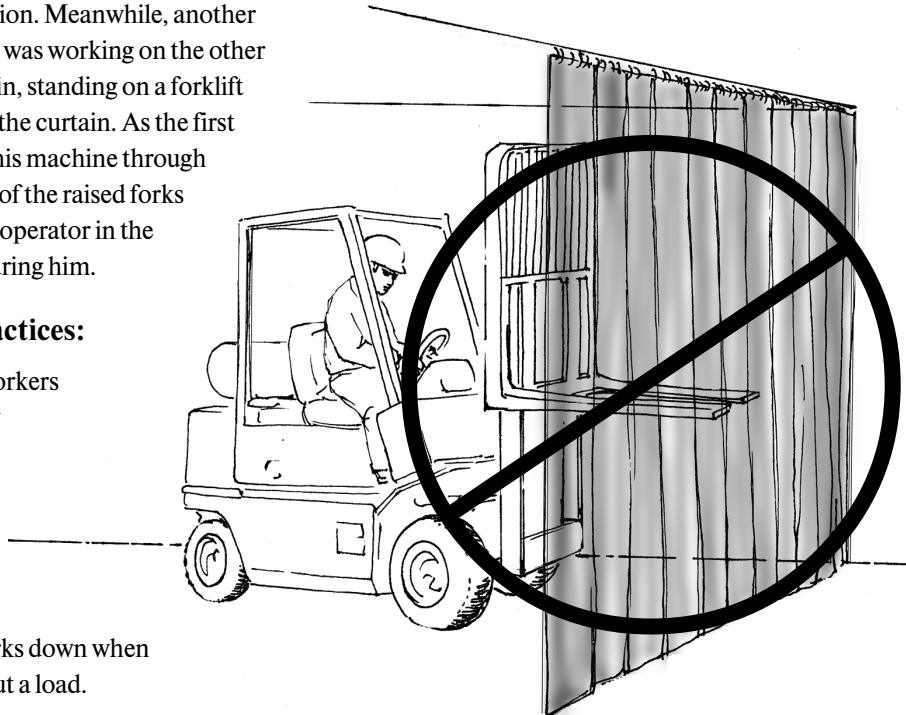
A forklift operator was killed in a tragic accident where poor visibility played a major part in the incident. The fatal accident involved two forklift operators. One operator had just dropped off a load of empty pallets with his forklift. He turned his forklift to pick up another load. He then drove his machine forward through a set of plastic curtains that separated the warehouse work areas. The raised forks and the plastic curtain restricted his vision. Meanwhile, another forklift operator was working on the other side of the curtain, standing on a forklift with his back to the curtain. As the first operator drove his machine through the curtain, one of the raised forks struck the other operator in the back, fatally injuring him.

- Ensure that workers are adequately directed and instructed in how to perform their duties safely.
- Travel with forks down when moving without a load.
- Ensure that plastic curtains (or similar barriers) are maintained and kept in good working order.
- Provide a system of traffic control or other type of warning system when a forklift operator's vision may be obstructed
