POSTER # 95-02

Use caution when backing down inclines

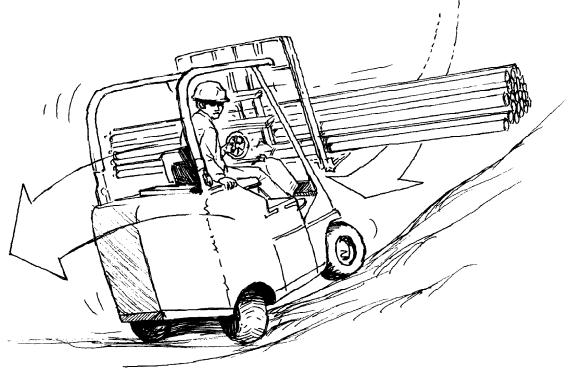
A forklift operator was backing a machine down a 21-percent slope when he tried to turn the loaded forklift. The right rear wheel started to climb a steep bank and the machine tipped over. He suffered fatal injuries when his head was crushed by the metal protective structure. He was not wearing a seat belt. A seat belt may have secured him from falling against the protective structure.

- Develop written safe work procedures for forklift operations.
- Do not turn sideways when operating a forklift on an incline.
- Wear a seat belt when a forklift is equipped with one.
